FRONTZAHNKRONE | ANTERIOR CROWN

SEITENZAHNKRONE | POSTERIOR CROWN

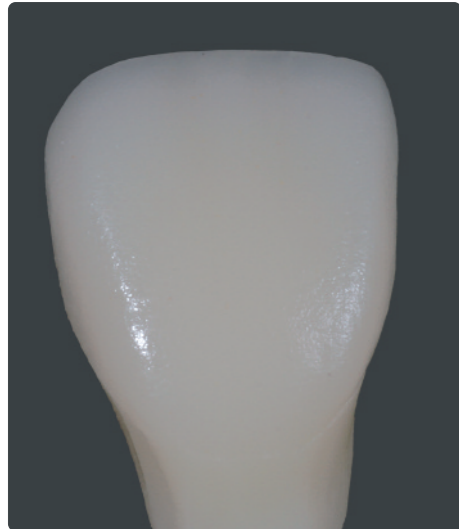
Ausgangssituation  
Starting situation

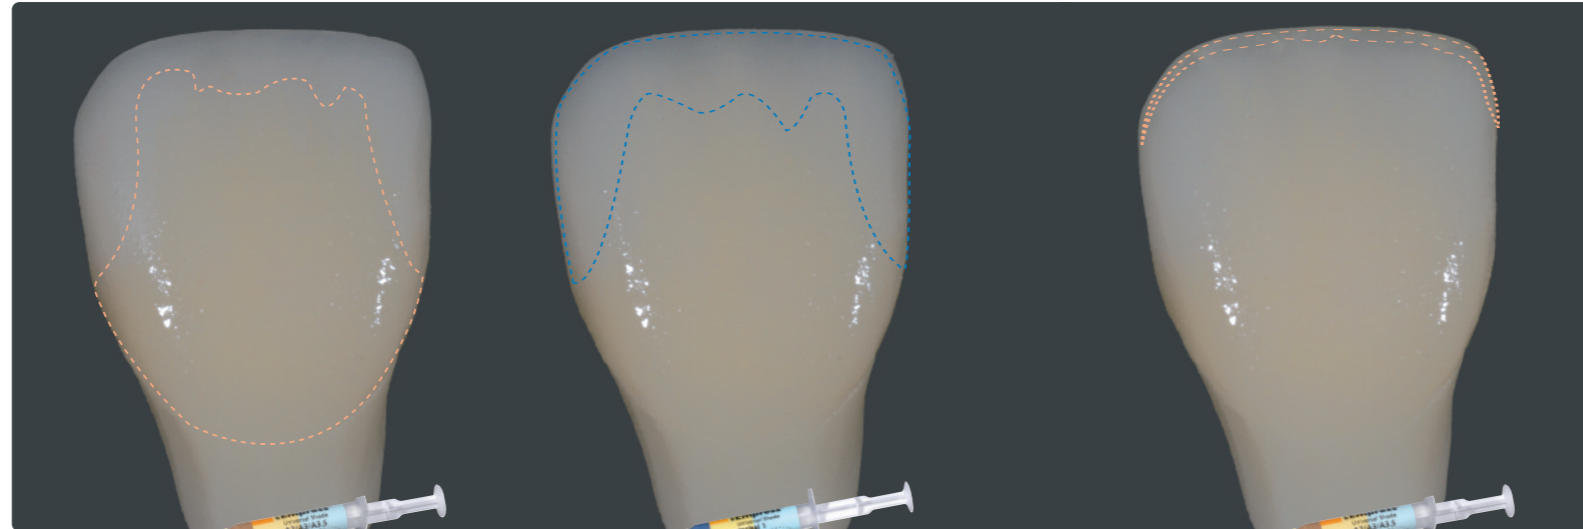
1. Schritt / 1<sup>st</sup> Step:  
Dentin: Shade A2

2. Schritt / 2<sup>nd</sup> Step:  
Incisal: Shade I1

3. Schritt und Brennen / 3<sup>rd</sup> Step and firing:  
Halo: Shade A2

Brennparameter Malfarben- und Charakterisierungsbrand  
Firing parameters Stains and characterization firing

B	S	t <sup>➤</sup>	T	H	V <sub>1</sub>	V <sub>2</sub>
403°C	6 min	100°C	790°C	1 min	450°C	789°C
757°F	6 min	180°F	1454°F	1 min	842°F	1453°F

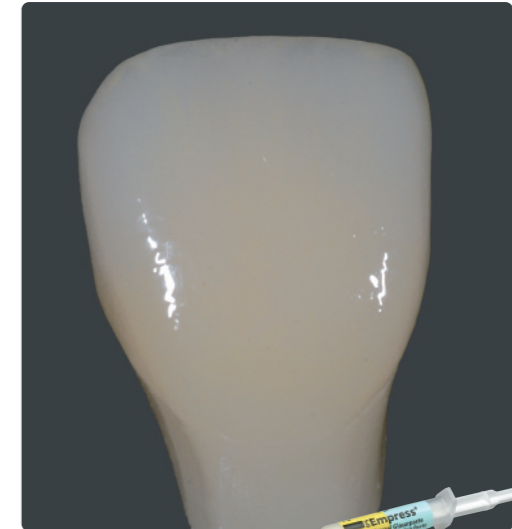
Endsituation glasiert  
Completed restoration glazed

Brennparameter Glanzbrand  
Firing parameters Glaze firing

B	S	t <sup>➤</sup>	T	H	V <sub>1</sub>	V <sub>2</sub>
403°C	6 min	100°C	790°C	1–2 min	450°C	789°C
757°F	6 min	180°F	1454°F	1–2 min	842°F	1453°F

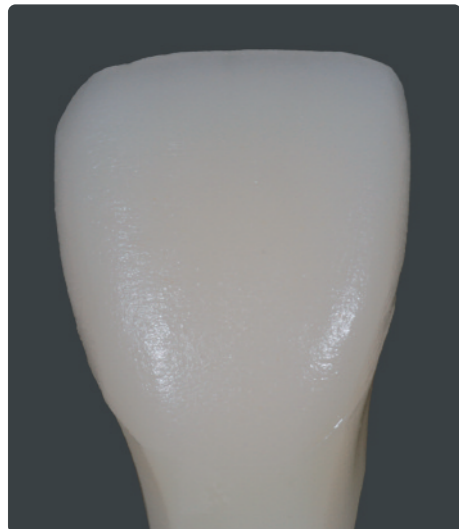
Ausgangssituation  
Starting situation

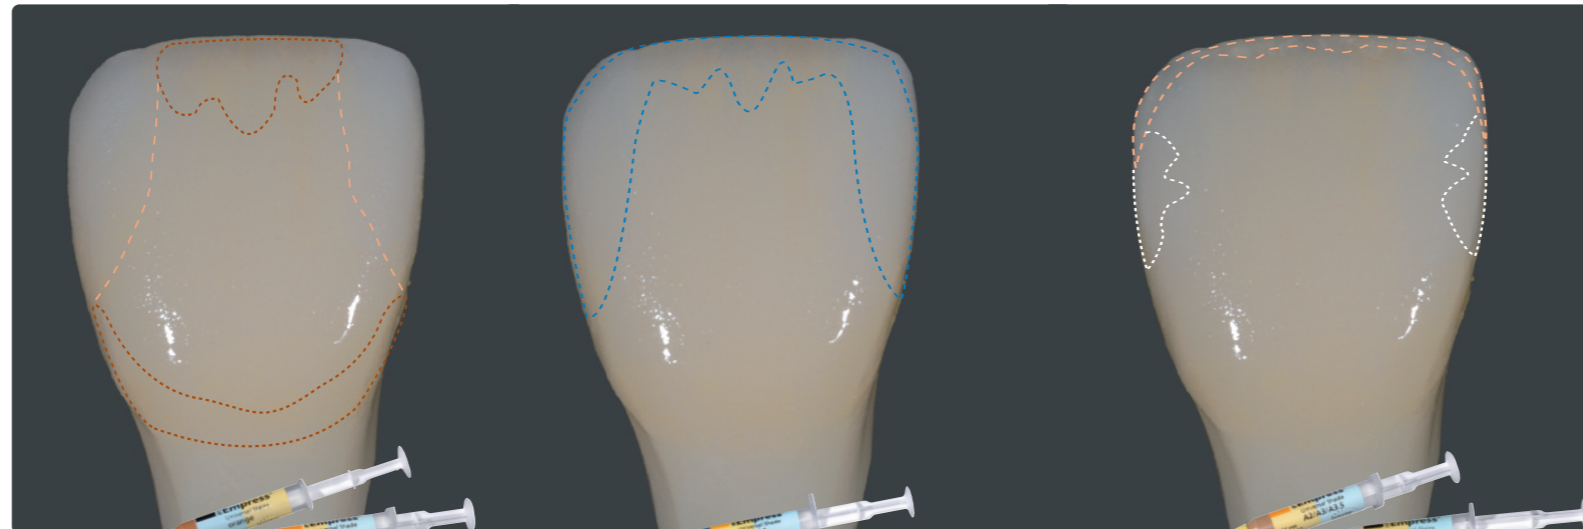
1. Schritt / 1<sup>st</sup> Step:  
Cervical/Incisal: Stains orange  
Dentin: Shade A2

2. Schritt / 2<sup>nd</sup> Step:  
Incisal: Shade I1

3. Schritt und Brennen / 3<sup>rd</sup> Step and firing:  
Halo: Shade A2  
Approximal / proximal: Stains white

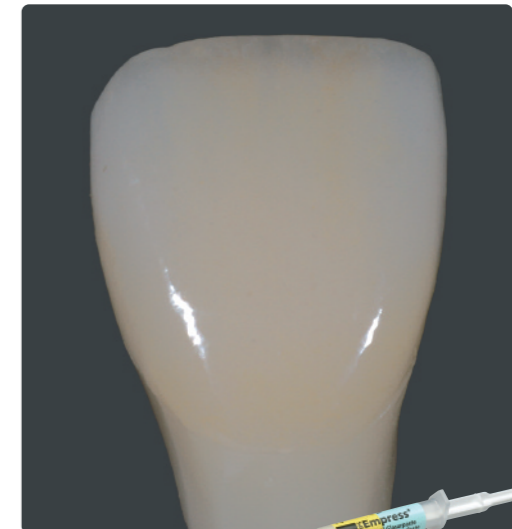
Endsituation glasiert  
Completed restoration glazed

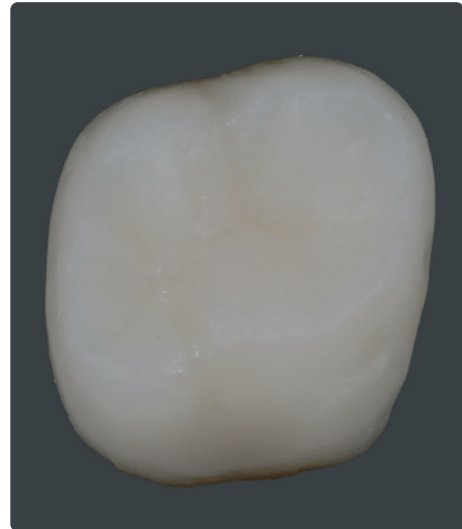
Ausgangssituation  
Starting situation

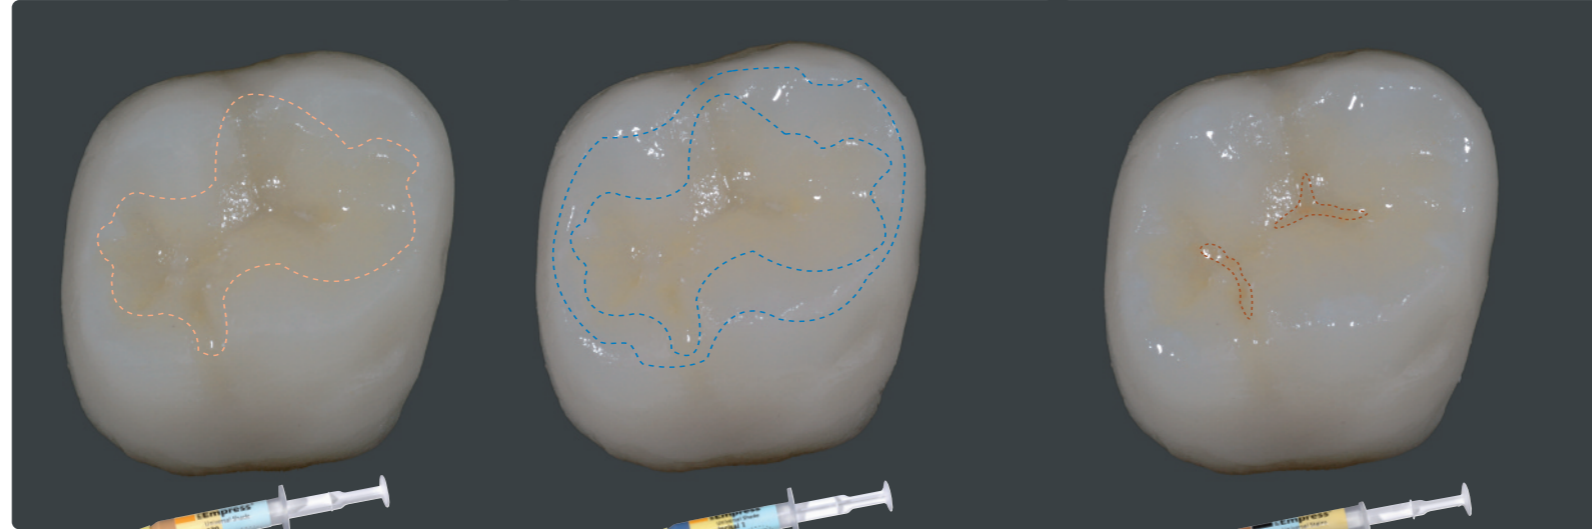
1. Schritt / 1<sup>st</sup> Step:  
Occlusal: Shade 130

2. Schritt / 2<sup>nd</sup> Step:  
Incisal: Shade I1

3. Schritt und Brennen / 3<sup>rd</sup> Step and firing:  
Fissur / fissure: Stains orange

Brennparameter Malfarben- und Charakterisierungsbrand  
Firing parameters Stains and characterization firing

B	S	t <sup>st</sup>	T	H	V <sub>1</sub>	V <sub>2</sub>
403°C	6 min	100°C	790°C	1 min	450°C	789°C
757°F	6 min	180°F	1454°F	1 min	842°F	1453°F

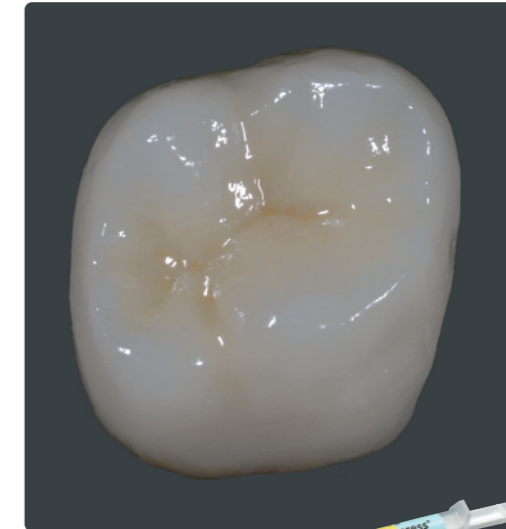
Endsituation glasiert  
Completed restoration glazed

Brennparameter Glanzbrand  
Firing parameters Glaze firing

B	S	t <sup>st</sup>	T	H	V <sub>1</sub>	V <sub>2</sub>
403°C	6 min	100°C	790°C	1–2 min	450°C	789°C
757°F	6 min	180°F	1454°F	1–2 min	842°F	1453°F

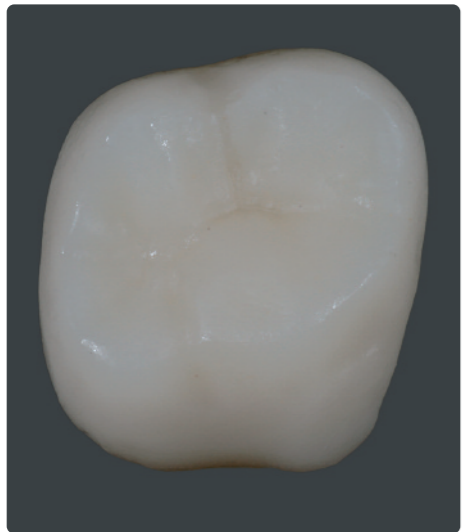
Ausgangssituation  
Starting situation

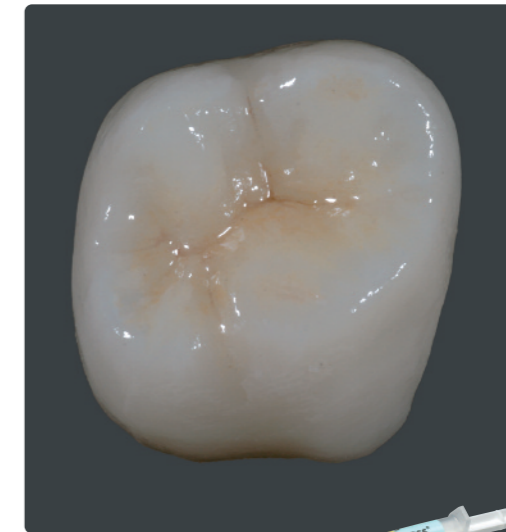
Endsituation glasiert  
Completed restoration glazed
