IPS®
e.max

SCIENTIFIC REPORT

Vol. 02 / 2001 – 2013

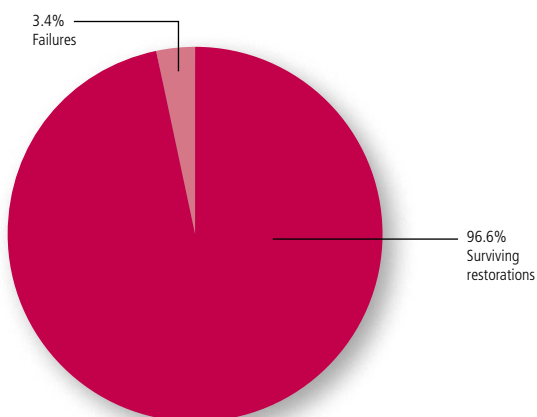
Fig. 1: Summary of the results of 20 clinical studies involving restorations (crowns and bridges) fabricated with IPS e.max materials; the distribution of success cases and failures is presented in percent.

The survival rates* of IPS e.max Press (6 studies), IPS e.max CAD (6 studies) and IPS e.max ZirCAD (8 studies) were combined and the overall survival rate of the entire system was calculated. A total of 1276 restorations from 20 clinical studies were included. The resulting overall survival rate for the IPS e.max system is 96.6%.

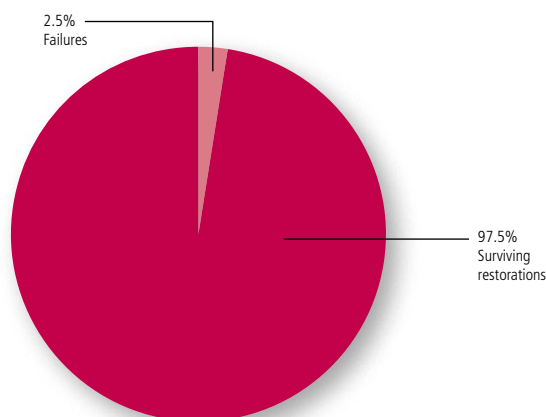
Fig. 2: Summary of the results of 6 clinical studies involving IPS e.max Press restorations (crowns); the distribution of success cases and failures is presented in percent.

Five external clinical studies (Böning et al., 2006; Etman and Woolford, 2010; Guess et al., 2012; Gehrt et al., 2012; Dental Advisor 2012) and an internal Ivoclar Vivadent study with a combined total of 642 restorations (crowns) have shown a survival rate of 97.5% after a mean observation period of 5.6 years. The 2.5% failures** include fractures (1.6%), endodontic failure (0.2%) and secondary caries (0.2%). Moreover, 4 crowns (0.6%) were removed in one study because of crack development. Chipping occurred in 3.4% of the restorations. However, all cases could be repaired in situ. Conventional and adhesive cementation work equally well.

Systematic reviews of the survival rates of conventional glass-ceramic materials determined fracture rates of 3.8% (Heintze and Rousson, 2010a). The survival rate of metal-ceramic crowns is 95.6% after 5 years (Pjetursson et al., 2007). Biological or technical failures, such as endodontic failures or chipping, are reported to occur with a frequency of 5 to 10%. With a fracture rate of 1.6% and a survival rate of 97.5%, IPS e.max Press demonstrates a clearly better clinical performance than conventional materials such as glass- or metal-ceramics.

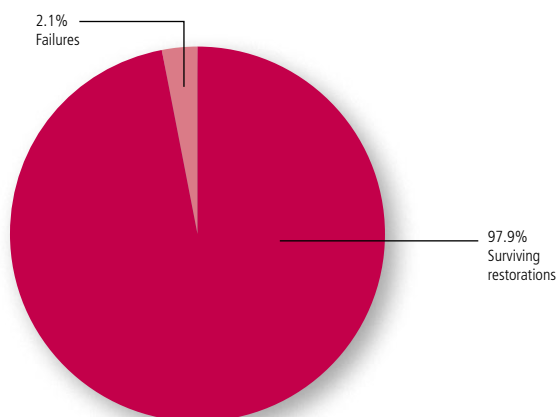
Fig. 3: Summary of the results of 6 clinical studies involving IPS e.max CAD restorations (crowns); the distribution of success cases and failures is presented in percent.

Six clinical studies (Richter et al., 2009; Nathanson, 2008; Reich et al., 2010; Fasbinder et al., 2010; Bindl, 2011; Sorensen et al., 2009b) with a total of 237 restorations (crowns) showed that 97.9% of the restorations survived after a mean observation period of 3 years. The failure rate of 2.1% includes 0.4% irreparable chipping and 1.7% fractures. In addition to the above case of irreparable chipping, no further chipping occurred.

With a survival rate of roughly 98% and a fracture rate of only 1.7%, the clinical performance of IPS e.max CAD is also clearly better than that of metal-ceramics and other ceramics (Pjetursson et al., 2007).

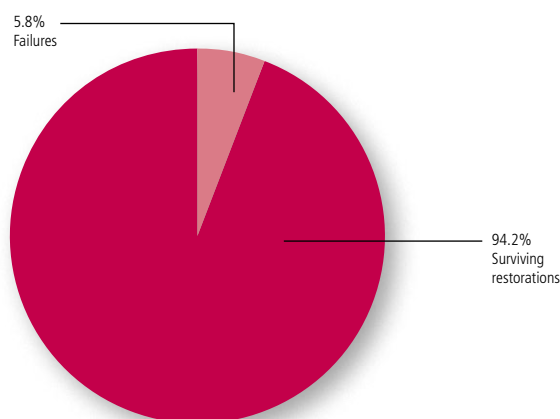
Fig. 4: Summary of the results of 8 clinical studies involving IPS e.max ZirCAD restorations (crowns, bridges); veneered with IPS e.max ZirPress and/or IPS e.max Ceram; the distribution of success cases and failures are presented in percent.

Eight clinical studies (Stanford 2009; Sorensen et al. 2009a; Fasbinder and Dennison 2009; Beuer, 2011B; Gehrt, 2012; Christensen et al., 2008; Muñoz 2009; Holmes et al. 2012) involving a total of 397 restorations have shown a survival rate of 94.2%. The failure causes include 2.3% irreparable chipping, 2.0% fractures, 0.8% endodontic failure and one root fracture (0.3%). Moreover, 2 cases of repeated decementation were rated as failures. Chipping occurred in 12% of the restorations, but required replacement of the restoration in only 2.3% of the cases.

With roughly 2.0%, the fracture rate of IPS e.max ZirCAD is below the value reported in the literature for zirconium oxide bridges (approximately 6% after 5 years). Technical and biological complications occurred clearly less frequently with IPS e.max ZirCAD than in the literary references.

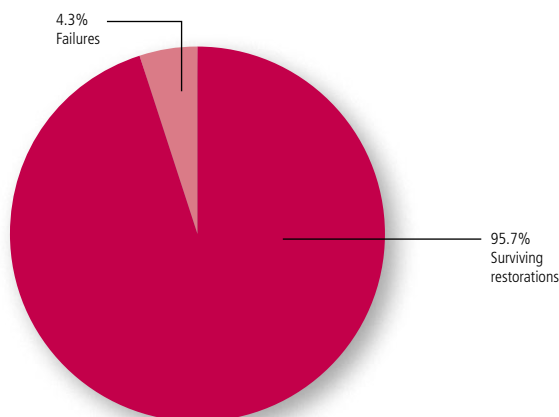
Fig. 5: Summary of the results of 4 clinical studies involving IPS e.max ZirPress on IPS e.max ZirCAD restorations (crowns, and bridges); the distribution of success cases and failures is presented in percent.

Four clinical studies (Gehrt et al., 2012; Christensen et al., 2008; Holmes et al., 2012; Fasbinder and Dennison, 2009), involving a total of 186 restorations (123 crowns, 63 bridges) made of IPS e.max ZirPress as a veneer on zirconium oxide have shown a survival rate of 95.7%. Chipping occurred in 15% of the restorations, but was irreparable in only 1.6% of the cases. All other chipping incidents could be repaired *in situ* by means of polishing or composite. The overall failure rate was 4.3%, which includes a case of root fracture (0.5%) as well as 2 endodontic failures (1.1%).

With IPS e.max ZirPress, non-repairable chipping occurs in 1.6% of the restorations and is thus at the lower end of the frequency described in the literature.

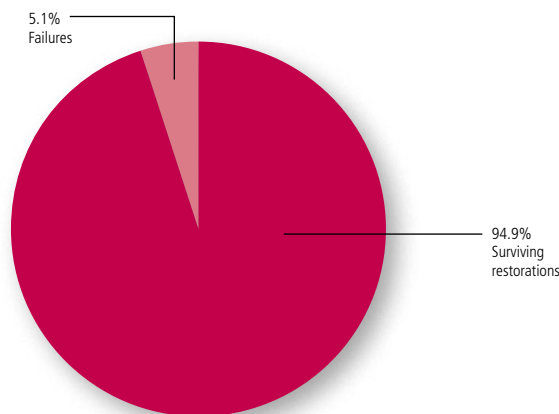
Fig. 6: Summary of the results of 8 clinical studies involving IPS e.max Ceram on IPS e.max ZirCAD or IPS e.max CAD restorations and Crystal Zirconia (crowns, bridges); the distribution of success cases and failures is presented in percent.

Eight clinical studies (Dental Advisor 2010; Nathanson 2008; Richter et al. 2009; Stanford 2009; Sorensen et al. 2009a; Fasbinder and Dennison 2009; Beuer, 2011b; Holmes et al., 2012), involving a total of 369 restorations veneered with IPS e.max Ceram have shown a survival rate of 94.9%. The failures include 2.4% irreparable chipping, 1.9% fracture of the framework (different materials), 0.5% endodontic failure, and a decementation rated as failure (0.3%). Chipping occurred in 6% of the restorations. However, more than half of them could be repaired *in situ*.

With IPS e.max Ceram, chipping occurs in 6% of the restorations, thus less frequently than described in the literature. Furthermore, it was non-repairable in only 2.4% of the cases, which is in the range of the literature data.

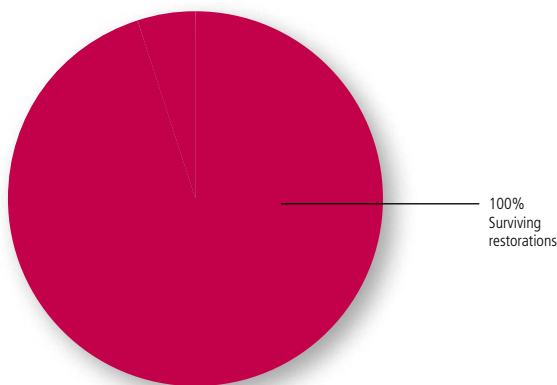
Fig. 7: Summary of the results of 2 clinical studies involving IPS e.max CAD on IPS e.max ZirCAD restorations (bridges and crowns); the distribution of success cases and failures is presented in percent.

A total of 29 three-unit bridges were examined in 2 studies (Watzke et al., 2012; Blatz et al., 2012). So far no failures have occurred. The survival rate is 100%. Another study with 30 bridges was started in 2012 (Sailer et al., 2012). Furthermore, 40 IPS e.max CAD-on crowns were seated in a total of 2 studies. In one study (Watzke et al., 2012), no failures were observed up to 36 months. The other study (Beuer et al., 2012) started in 2012. The survival rate for restorations fabricated in the CAD-on technique is 100%.

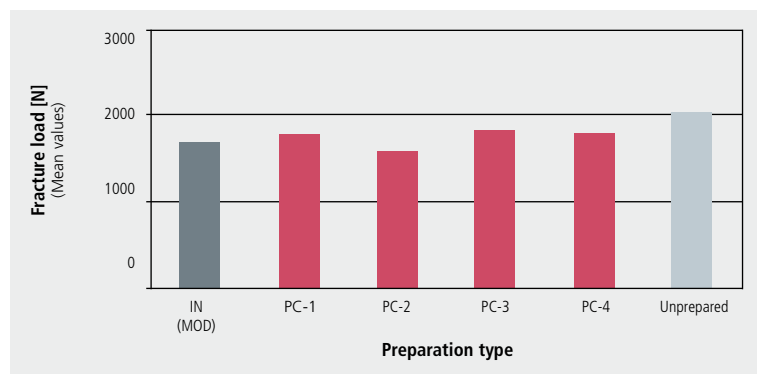
Fig. 8: Fracture load of natural molars with partial crowns prepared according to various preparation designs

The fracture load of natural molars with all-ceramic monolithic IPS e.max LS₂ partial crowns with different preparation designs was determined. Teeth with and without MOD inlay preparation were used as control group. The partial crown preparations included 1–4 occlusal cusps (PC-1, PC-2, PC-3, PC-4). The partial crowns were adhesively cemented (Variolink® II). All test specimens were subjected to masticatory simulation and thermocycling (1.2 million cycles, 98 N, 5°/55°C) and subsequently loaded to breaking point in a universal testing machine.

All specimens achieved a 100% *in vitro* survival rate in the masticatory simulator. Irrespective of the size of the ceramic IPS e.max LS₂ restoration, the fracture load values achieved in the posterior region did not significantly differ from that of natural, unprepared teeth.

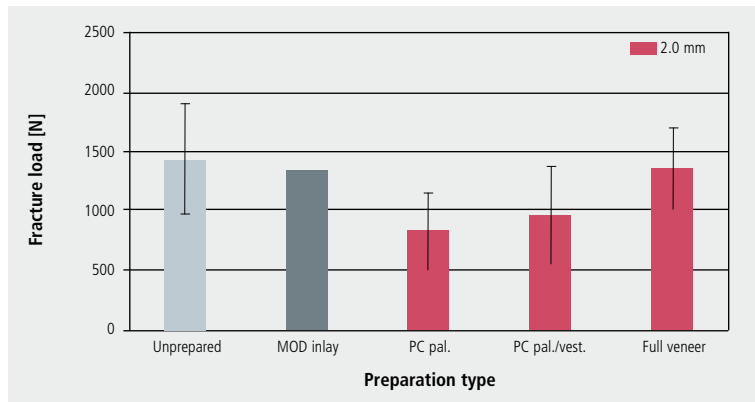
Fig. 9: Mean fracture load values in upper premolars in conjunction with partial crowns and full veneers with various preparation designs after masticatory simulation

In natural upper premolars, the effect of various preparation designs and layer thicknesses on the fatigue behaviour and fracture load was determined in all-ceramic partial crowns and veneers made of IPS e.max Press. Teeth with and without MOD inlay preparation were used as control groups. The partial crowns were adhesively cemented (Variolink II). All test specimens were subjected to masticatory simulation and thermocycling (1.2 million cycles, 49 N, 5°/55°C) and subsequently loaded to breaking point in a universal testing machine.

- The survival rate after more than 1.2 million cycles in the mastication simulator is 100% for all the partial premolar crowns tested.
- The fracture load of the partial palatal crowns (PC pal.) did not significantly differ from that of the partial crowns for which the entire occlusal surface was reduced (PC pal./vest.).
- The fracture load of MOD inlay preparations, as well as that of full veneers with an occlusal layer thickness of 2.0 mm and a facial segment of 0.8 mm does not significantly differ from the fracture load of unprepared natural premolars.

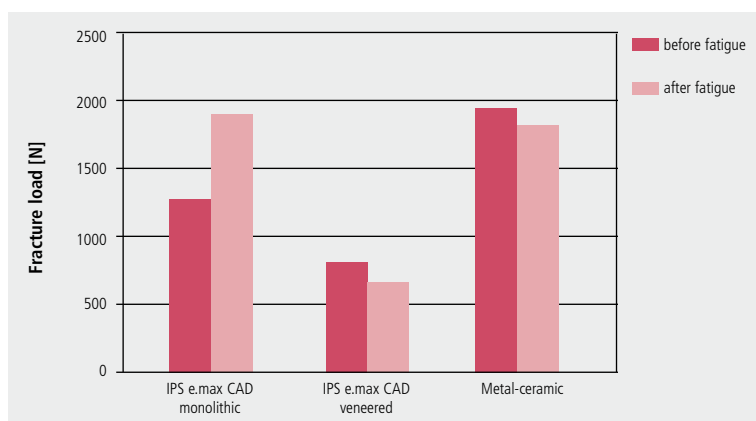
Fig. 10: Mean fracture load of bridges made of IPS e.max CAD (monolithic or veneered) as well as metal-ceramic after masticatory simulation

A total of 96 extracted human molars and premolars were divided into 3 groups. Full-contour bridges were milled of IPS e.max CAD using CEREC and either cemented as a monolithic restoration or manually veneered. Metal-ceramic bridges were used as the control group. The fracture load was determined before and after fatigues tests.

All bridges survived the fatigue test. Veneered bridges made of IPS e.max CAD fractured at lower forces than monolithic bridges made of IPS e.max CAD, which achieved a fracture load comparable to that of metal-ceramic. Bridges made of IPS e.max CAD fractured in the connector area. Chipping was not observed in the lithium disilicate bridges, while this was the only failure type in metal-ceramic bridges.

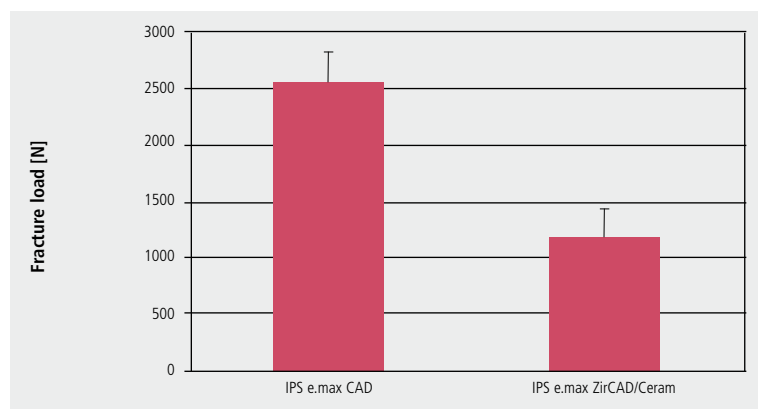
Fig. 11: Fracture load of IPS e.max CAD compared to IPS e.max ZirCAD veneered IPS e.max Ceram

Only with rather high forces did IPS e.max CAD (LS₂) crowns demonstrate fractures with cracks down to the composite die (2576 ± 206 N). In contrast, IPS e.max ZirCAD (ZrO₂) exclusively showed fractures in the IPS e.max Ceram veneering ceramic (1195 ± 221 N).

Fully anatomical IPS e.max CAD crowns showed to be resistant against fatigue in cyclic fatigue tests. In comparison, crowns made of zirconium oxide failed by fractures in the veneering material at clearly lower loads.

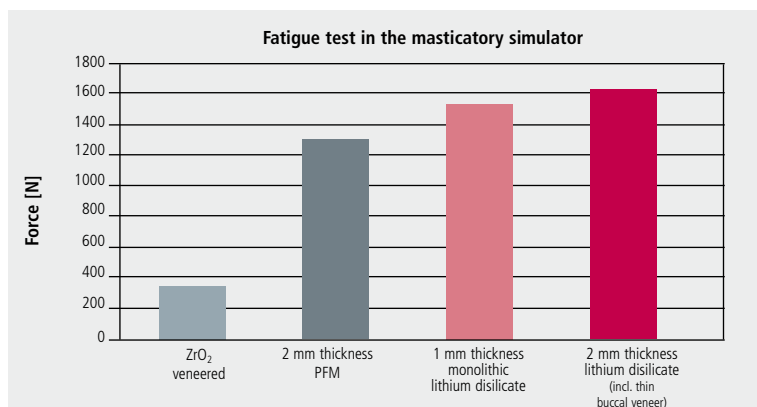
Fig. 12: Force upon failure after stress during the fatigue test

The fracture load of monolithic IPS e.max CAD (LS₂) restorations was 1535 N for IPS e.max CAD 1 mm and 1610 N for IPS e.max CAD 2 mm. These values are comparable to those of metal-ceramic (1304 N) and higher than those of veneered zirconium oxide (371 N) (see Figure). The fractures observed were complete fractures for IPS e.max CAD and chipping for the two other groups. The IPS e.max CAD material showed the highest reliability.

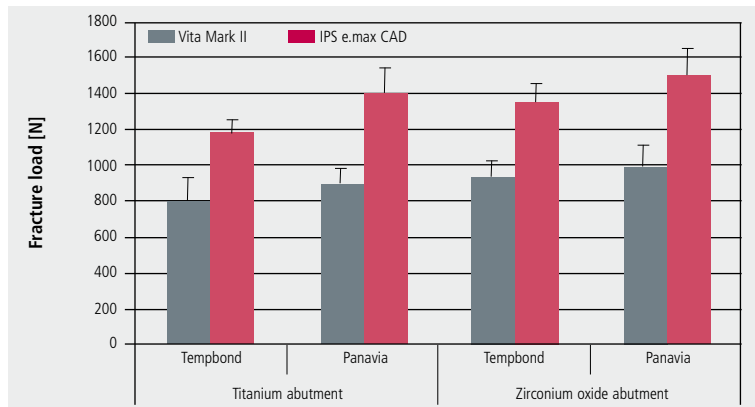
Fig. 13: Fracture load of implant-retained crowns made of IPS e.max CAD or Vita Mark II on titanium or zirconium abutments. Cementation was carried out with either Tempbond or Panavia.

A total of 64 implant replicas were divided into 8 groups. Various ceramic materials (Vita Mark II, IPS e.max CAD), various abutments (titanium, zirconium), as well as different cementation materials (Tempbond, Panavia) were compared. The molar crowns were cemented to implants and stored in water at 37°C for 24 hours, before an underwater fatigue test at 55–550 N for 500,000 cycles was conducted. The surviving test specimens were subjected to a fracture test.

During the fatigue test, 2 Vita Mark II crowns fractured (1 on a titanium abutment, 1 on a zirconium abutment, both cemented with Tempbond). All the other test specimens survived.

The group with the IPS e.max CAD crowns achieved statistically significantly higher fracture load values than the groups with Vita Mark II crowns.

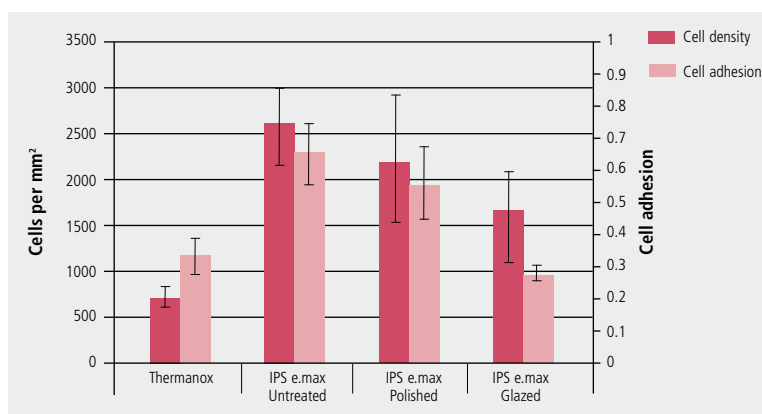
Fig. 14: Cell growth on IPS e.max test specimens with different surface treatments (untreated, polished, glazed)

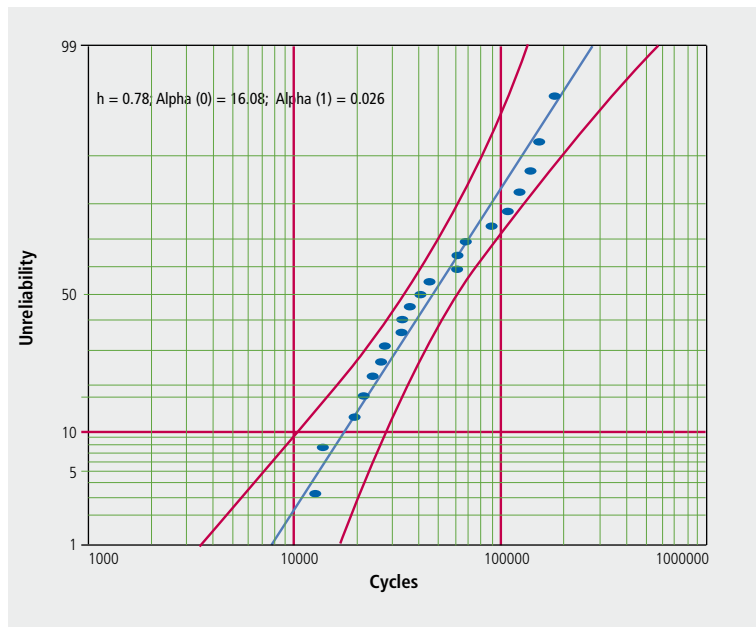
Fig. 15: Weibull probability curve for implants with abutments made of IPS e.max Press at a load of 200 N

Implants (Implant Direct 4.3 mm, Nobel Biocare) were placed in a cylindrical polycarbonate mould filled with PMMA at a 30° angle and polymerized. Hybrid abutments made of IPS e.max Press cemented onto a titanium sleeve with Multilink Implant (n=24) were manually screwed on with the help of a torque wrench. IPS e.max Press crowns were cemented onto the abutment with Multilink Automix. The test samples were stored in water at 37°C for at least 7 days. Three specimens were subjected to a test involving loading until fracture in a universal testing machine. The load of 0.5 mm/min. was constantly applied with a tungsten carbide piston (6.25 mm) 2 mm cervical to the lingual incisal edge with a mesio-distal sliding motion of 0.7–1.0 mm.

The reliability of the remaining 21 test specimens was tested with a three-stage stress test. After the tests, the test specimens were inspected for damage under the stereo microscope.

Hybrid abutment and hybrid abutment crown made of IPS e.max Press were able to withstand a load of 280 N to 100%. The weak point of the system was always the implant screw. It fractured before any damage to the crown or abutment occurred.

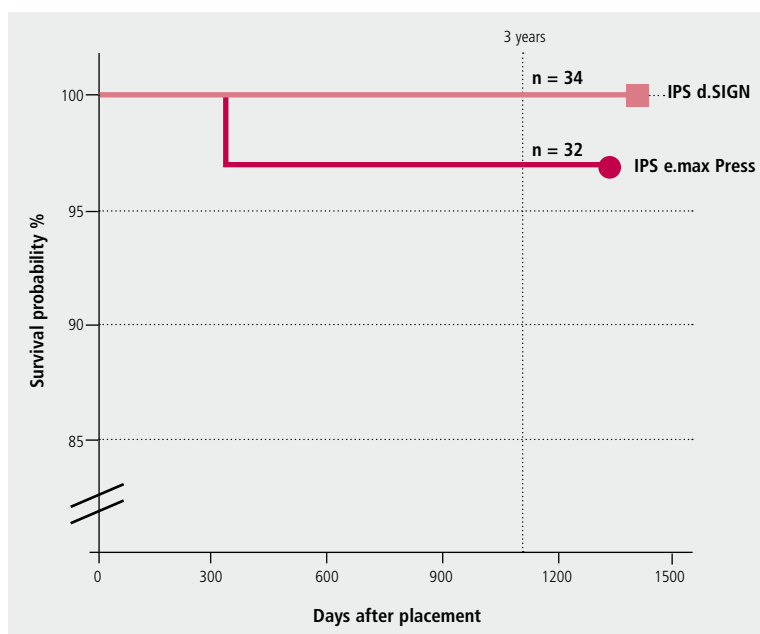
Fig. 16: Survival probability of crowns made of IPS e.max Press and IPS d.SIGN after 3 years

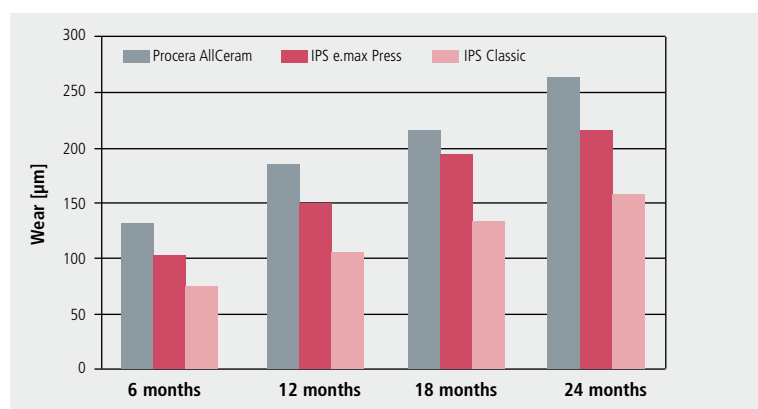
Fig. 17: Abrasion of the ceramic crowns in relation to the wear period

Impressions were taken at regular intervals during 2 years and the wear was determined.

Measurements after 2 years showed that IPS e.max Press crowns demonstrated less wear than Procera AllCeram crowns. The abrasion of the opposing tooth is also lower. After 7 years, the abrasion of enamel opposing IPS e.max Press crowns is still lower than that caused by Procera AllCeram crowns (only published as an abstract).

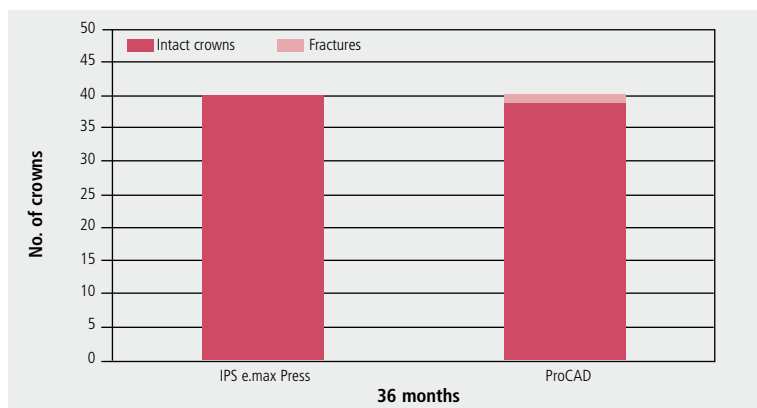
Fig. 18: Clinical efficiency of crowns made of IPS e.max Press and ProCAD after 7 years

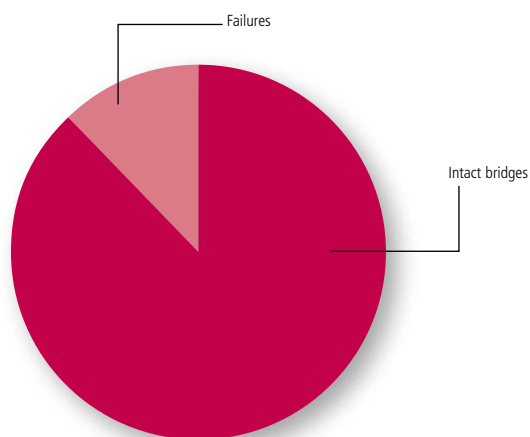
Fig. 19: Clinical efficiency of crowns made of IPS e.max Press after 121 months

After 10 years, a total of 3 fractures (in the molar region) occurred, and another restoration was lost due to the extraction of a tooth for biological reasons. Chipping occurred in 6.1% of the restorations. The 10-year survival rate according to Kaplan Meier is 87.9%.

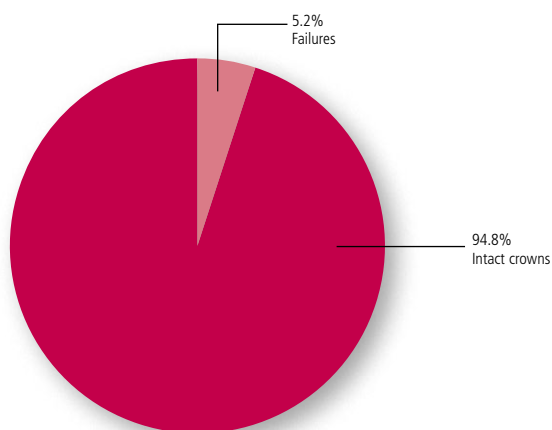
Fig. 20: Clinical efficiency of crowns made of IPS e.max Press after 8 years

The Kaplan Meier survival rate after 8 years was 94.8%. Two fractures occurred and another restoration failed due to secondary caries and yet another due to endodontic complications. Repairable chipping of the veneering material occurred in 3 crowns (3.3%) and 2 crowns required endodontic treatment with the crowns remaining *in situ*.

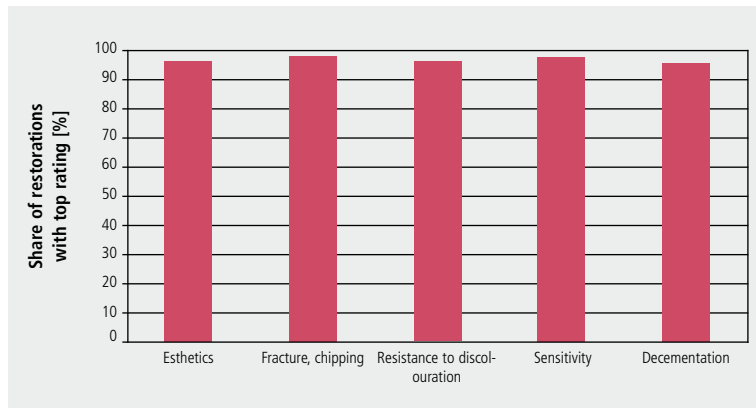
Fig. 21: Assessment of important clinical parameters of restorations made of IPS e.max Press after 5 years

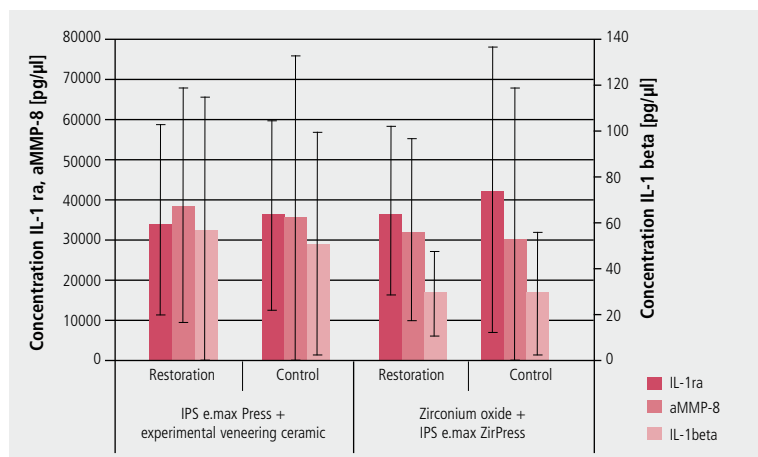
Fig. 22: Concentrations of inflammatory parameters (IL-1ra, aMMP-8, IL-1beta) in the sulcus liquid

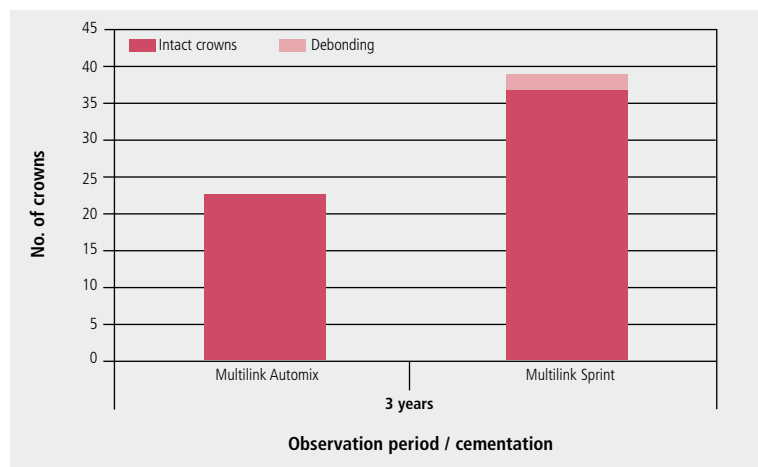
Fig. 23: Clinical efficiency of crowns made of IPS e.max CAD after 3 years

Crowns made of IPS e.max CAD proved their clinical efficiency over a period of 3 years; no fractures or chipping occurred.

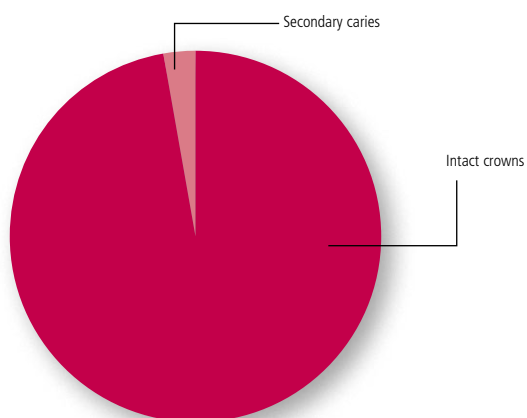
Fig. 24: Clinical efficiency of crowns made of IPS e.max CAD after 48 months

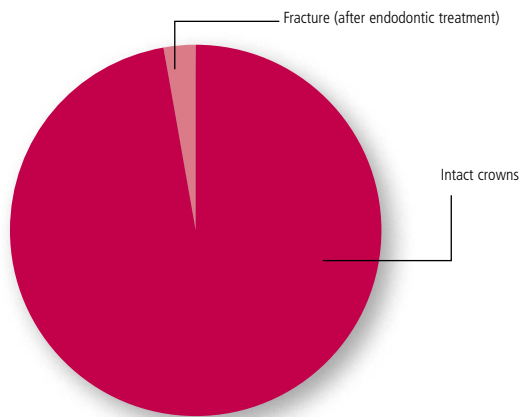
Fig. 25: Clinical efficiency of crowns made of IPS e.max CAD after 3 years

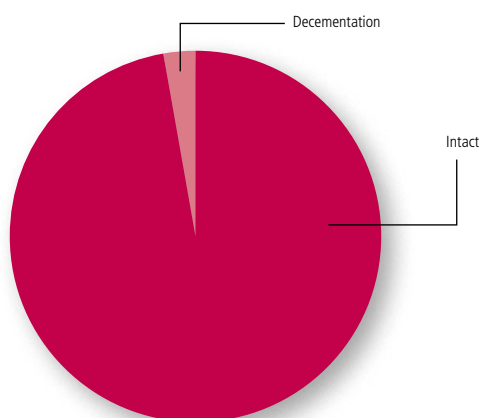
Fig. 26: Clinical efficiency of crowns made of IPS e.max CAD after 2 years

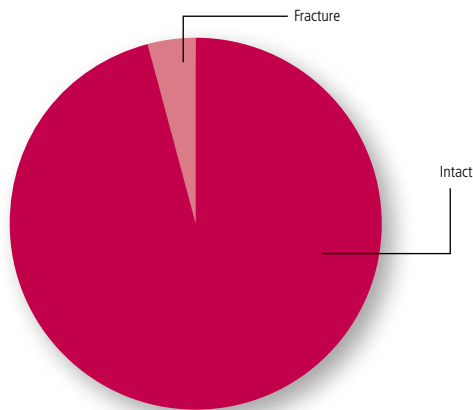
Fig. 27: Clinical efficiency of crowns made of IPS e.max CAD after 2 years

After an observation period of 2 years, two crowns were fractured.

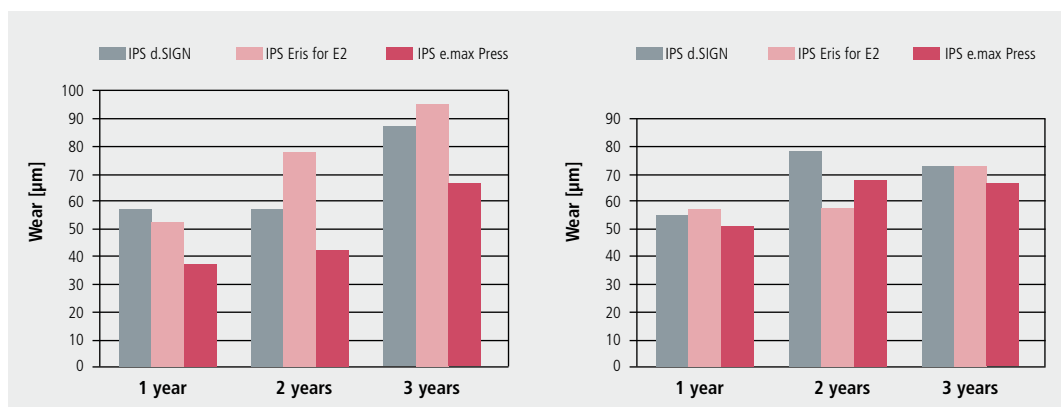
Fig. 28: Abrasion of the ceramic crowns in relation to the wear period

Fig. 29: Antagonist abrasion in relation to the wear period

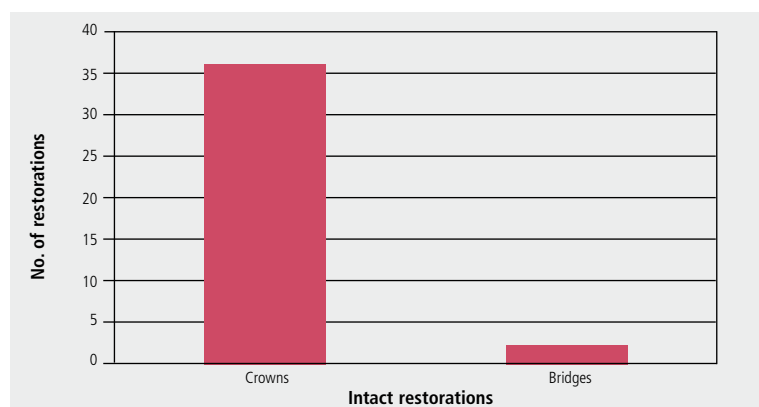
Fig. 30: Clinical efficiency of crowns and bridges made of IPS e.max CAD after 4 years

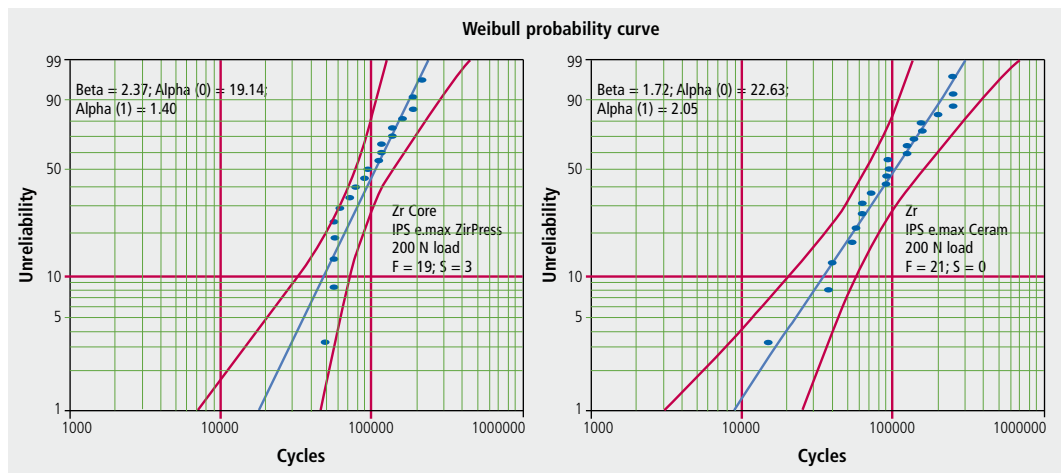
Fig. 32: Weibull probability curve for IPS e.max ZirCAD veneered with IPS e.max ZirPress (left) or IPS e.max Ceram (right).

Blue dots: data dots; red line: two-sided confidence intervals at 90%.

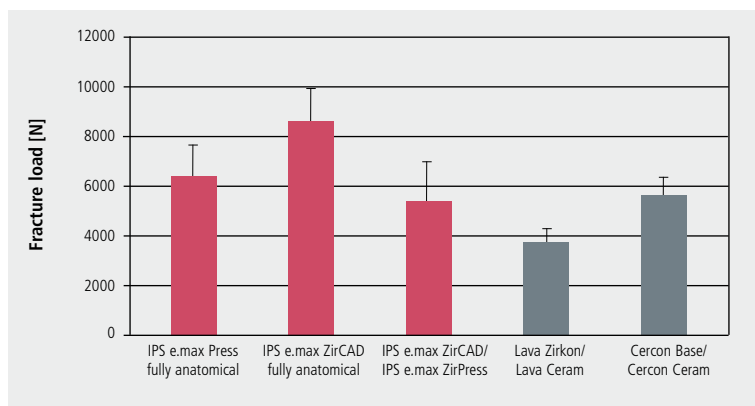
Fig. 33: Fracture load of all-ceramic crowns made of different materials

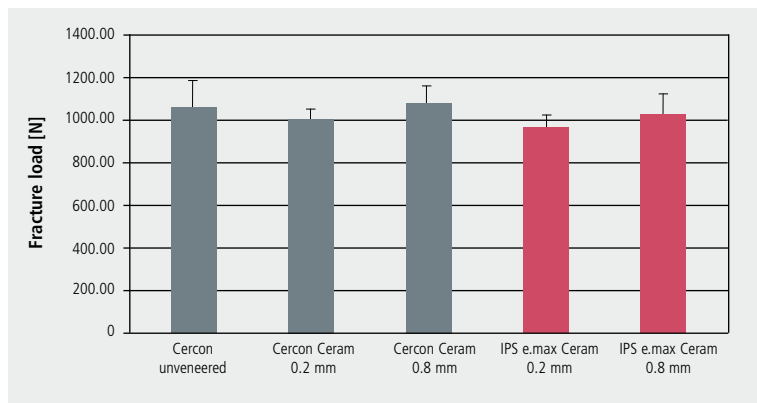
Fig. 34: Fracture load of unveneered and veneered Cercon ZrO₂ test specimens

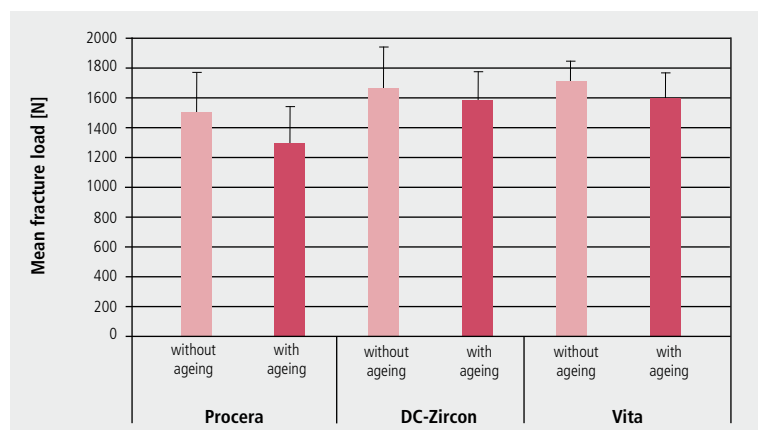
Fig. 35: Fracture load of ZrO₂ bridges, veneered with IPS e.max Ceram, before and after artificial ageing

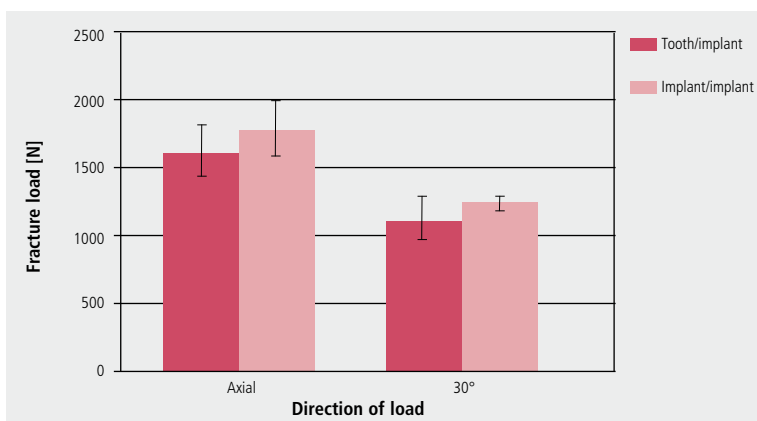
Fig. 36: Mean fracture toughness of differently supported (tooth/implant or implant/implant) CAD-on molar bridges after masticatory simulation

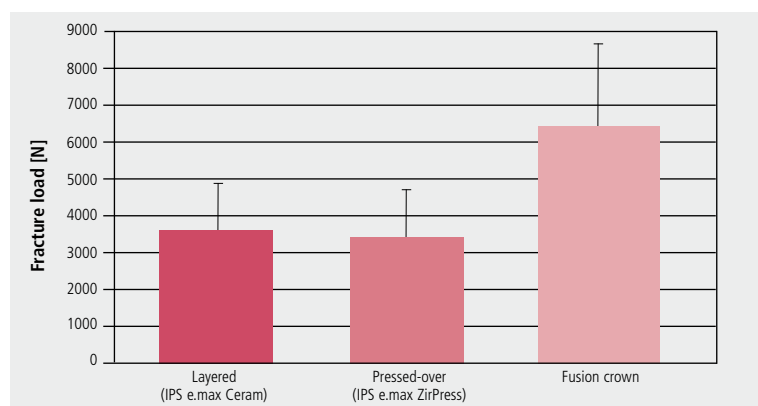
Fig. 37 : Fracture load of crowns made of IPS e.max ZirCAD veneered with IPS e.max Ceram, IPS e.max ZirPress or IPS e.max CAD-on (fusion crown)

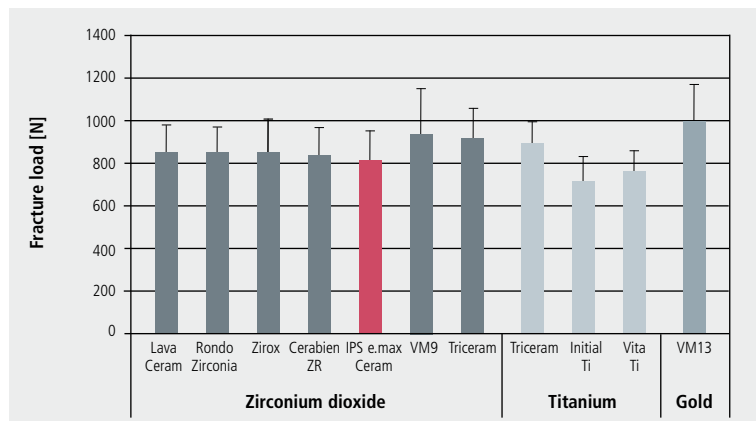
Fig. 38: Fracture load of veneered test specimens made of ZrO₂, titanium or gold

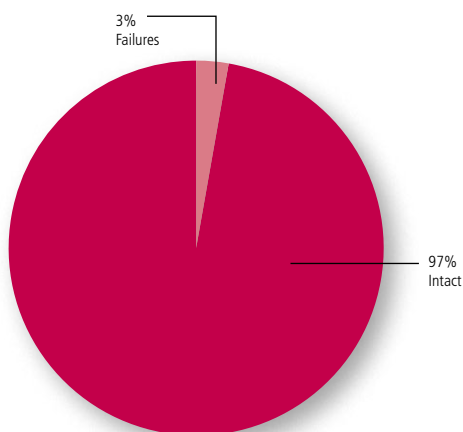
Fig. 39: Clinical efficiency of pressed-over zirconium oxide crowns after 5 years

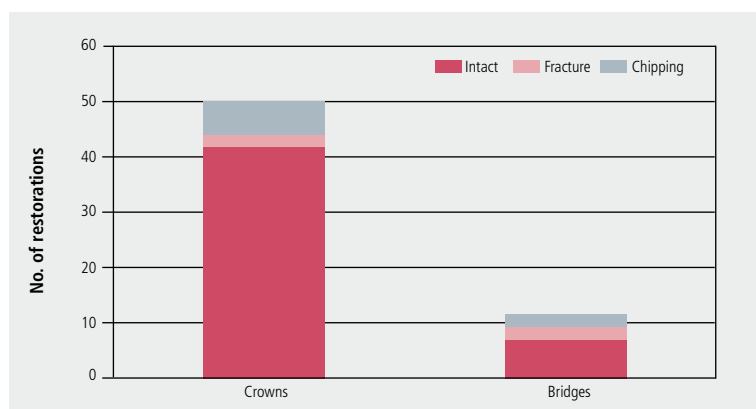
Fig. 40: Clinical efficiency of IPS e.max ZirCAD/Ceram-veneered restorations after 36 months

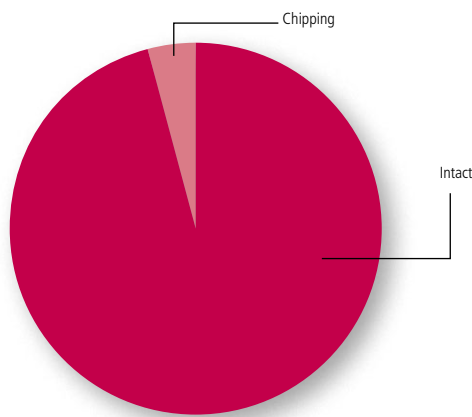
Fig. 41: Clinical efficiency of bridges made of IPS e.max ZirCAD veneered with IPS e.max Ceram

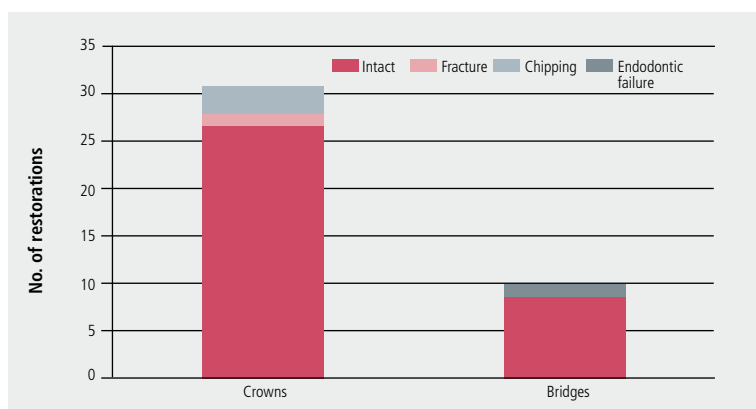
Fig. 42: Clinical efficiency of crowns and bridges made of IPS e.max ZirCAD, pressed-over with IPS e.max ZirPress

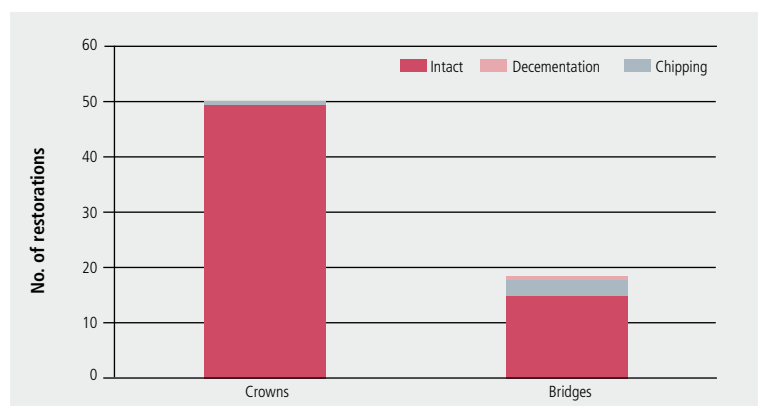
Fig. 43: Clinical efficiency of crowns and bridges made of IPS e.max ZirCAD and veneered with IPS e.max Ceram after 5 years

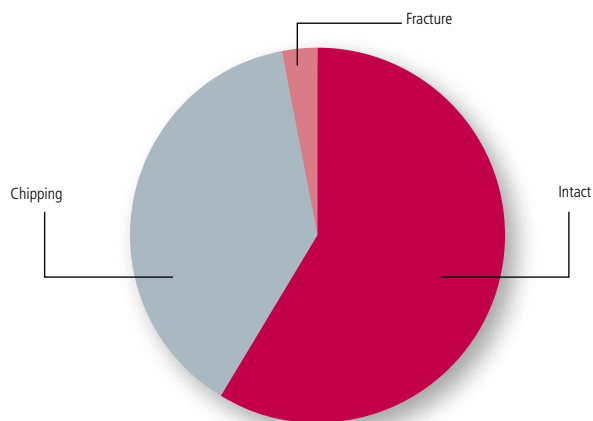
Fig. 44: Clinical efficiency of restorations made of IPS e.max ZirCAD pressed-over with IPS e.max ZirPress after 2 years

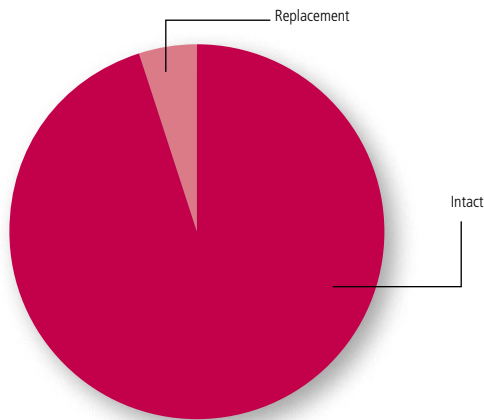
Fig. 45: Clinical efficiency of crowns made of IPS e.max ZirCAD

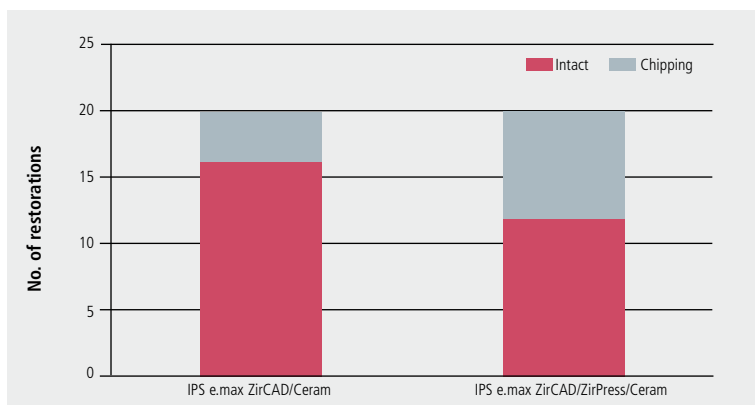
Fig. 46: Clinical efficiency of bridges made of IPS e.max ZirCAD veneered with different materials (IPS e.max Ceram or IPS e.max ZirPress) after 3 years

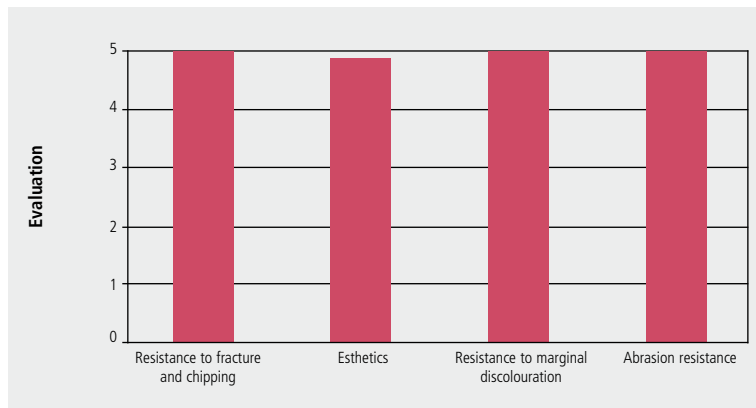
Fig. 47: Evaluation of restorations made of Crystal Zirconia veneered with IPS e.max Ceram after 1 year. 5=excellent; 4=very good; 3=good; 2=sufficient, 1=poor

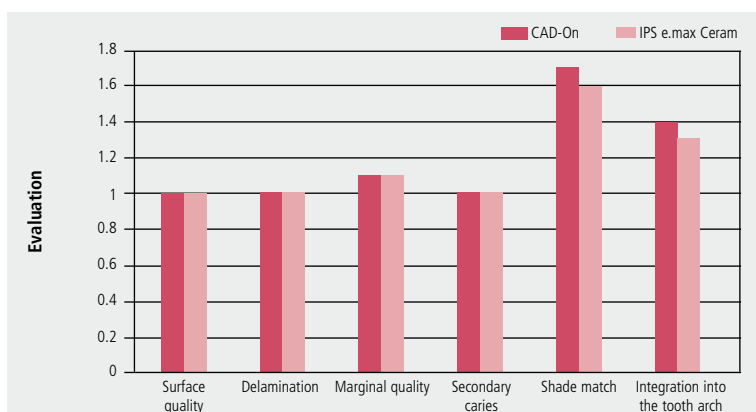
Fig. 48: Evaluation of bridges made of IPS e.max ZirCAD veneered with IPS e.max CAD (CAD-on technique) or IPS e.max Ceram

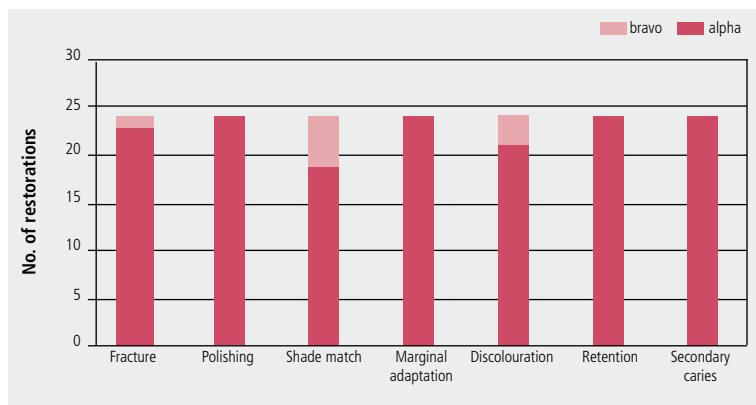
Fig. 49: Evaluation of restorations made of IPS e.max CAD-on IPS e.max ZirCAD (CAD-on technique) after 6 months

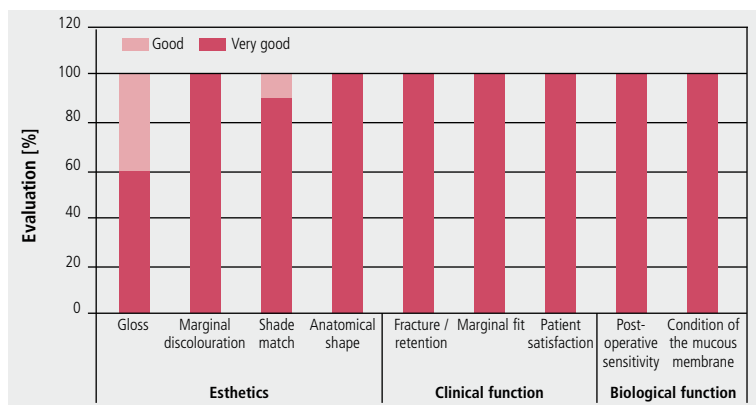
Fig. 50: Clinical efficiency of crowns and bridges made of IPS e.max ZirCAD and veneered with IPS e.max CAD ("CAD-on") after 12 months
